Where asbestos materials can be found in a residential property

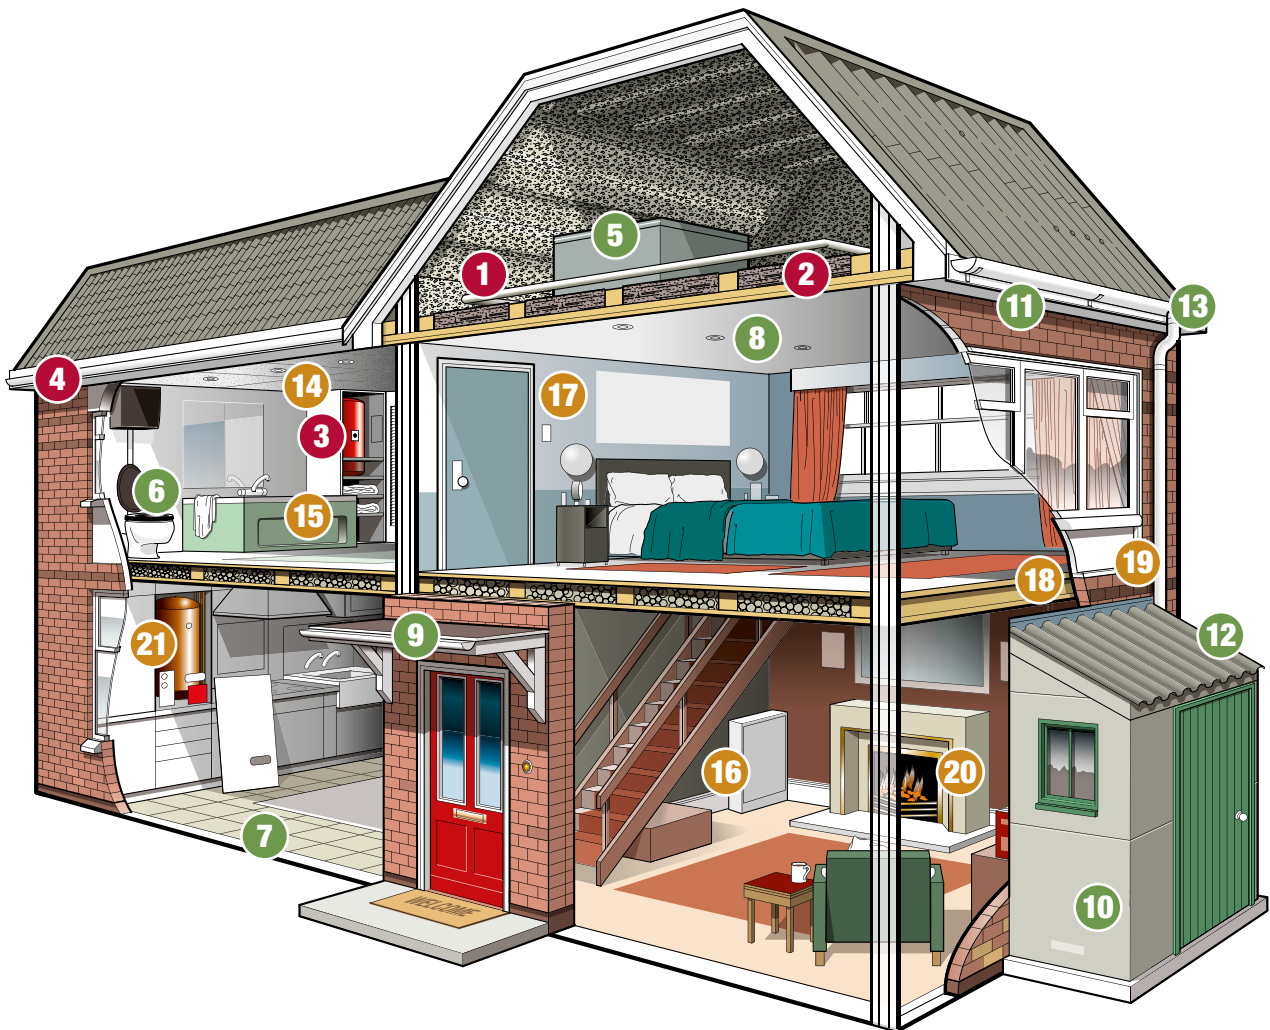
Usually licensed

- 1 Pipe lagging
- 2 Loose fill insulation
- 3 AIB airing cupboard and/or sprayed insulation coating on boiler and hot water tank
- 4 AIB soffits

Normally non-licensed

(If work that causes significant break up may require notification)

- 5 Asbestos cement water tank
- 6 Toilet seat and cistern
- 7 Vinyl floor tiles

- 8 Textured decorative coating on walls and ceilings eg Artex
- 9 Roofing felt
- 10 Asbestos cement panels
- 11 Asbestos cement soffits
- 12 Asbestos cement roof
- 13 Asbestos cement gutters and downpipes

If short duration non-licensed – otherwise licensed

- 14 AIB ceiling tiles
- 15 AIB bath panel
- 16 AIB behind fuse box

- 17 AIB partition wall
- 18 AIB interior window panel
- 19 AIB exterior window panel
- 20 AIB behind fire
- 21 AIB around boilers, storage heaters and warm air heating systems

AIB = Asbestos insulating board
